## Inspection Report

**Vintage single family home example  
Chicago IL**

**Property Inspected**  
Vintage single family home example  
Chicago IL

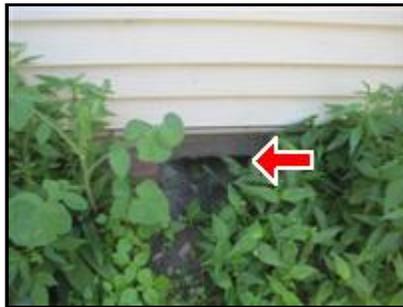
E. Picture 3

(4) The land under the enclosed back porch area is dirt. Expect this area to be damp and humid. This can attract creatures and wood boring insects as well as lead to mold growth. Consider either adding a vapor barrier over the dirt and/or venting this area to help improve air flow (after more insulation is added).

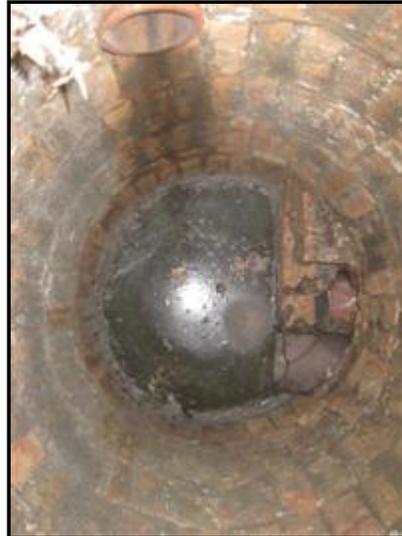
M. Picture 1

(2) The drain line in the catch basin no longer has a trap. This will allow debris in the basin to run through the drain line. We recommend adding a trap on this drain line. Consult with a qualified plumber to install a trap.

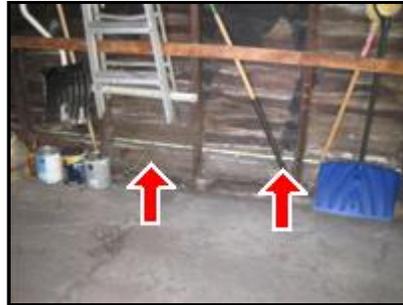
The garage siding is older and in need of repair or replacement. The wood is deteriorating and there are many gaps in the siding that are allowing water into the garage. Consult with a qualified siding contractor to determine if it will be less expensive to install new siding or restore the existing siding.

B. Picture 1 Gaps in siding

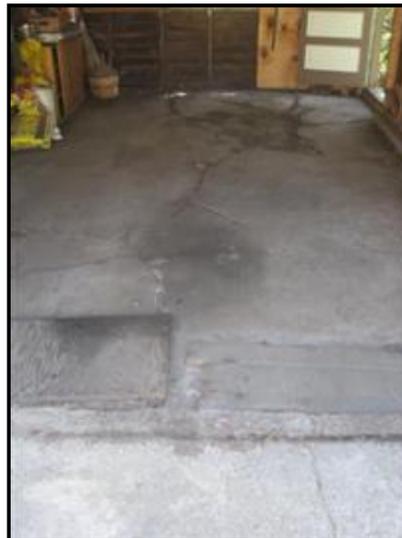
K. Picture 1

The garage slab is in very poor condition. The only real way to address the cracking and settling is to remove the existing concrete and pour a new slab. If the slab is to be replaced it will likely be cheaper to tear down the garage and rebuild then to try and repair all the other items in this section.

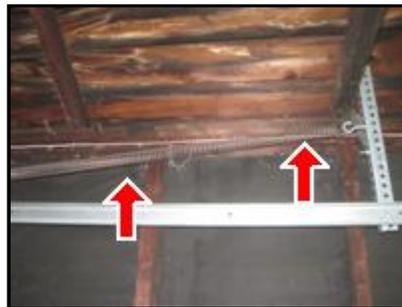
L. Picture 1

👉 (2) The springs for the garage door need safety cables installed. Safety cables are metal wires that run through the middle of the springs and attach at the ends. If the spring breaks and safety cables are installed then the springs cannot damage anyone or anything in the garage. Install safety cables.

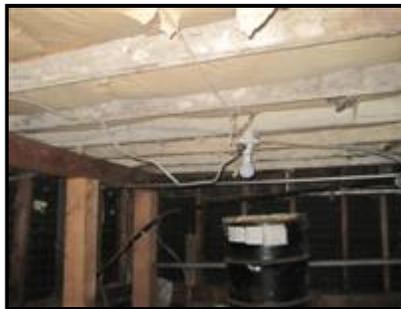
I. Picture 1

🏠 (3) The wiring under the back porch is in poor condition. Consult with a qualified electrician to add properly grounded circuits that run in solid metal conduit. Romex should not be used and wiring should not run out of light fixtures. See photo

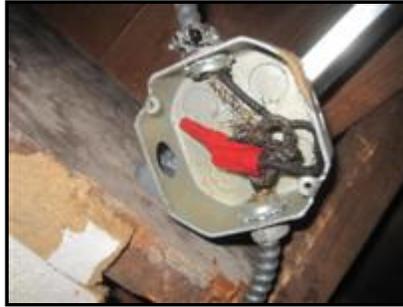
J. Picture 1

🏠 (1) Add covers over all exposed wiring throughout the home. All switch boxes, outlets and junction boxes should be covered so that no wiring is exposed.

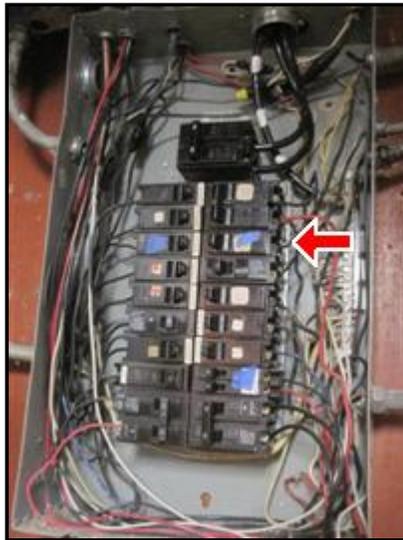
J. Picture 2

🏠 (2) Aluminum branch wiring was noted inside the electrical panel - 1 circuit on right side, 3rd breaker down. Aluminum wiring should not be used on the branches that run through the walls to switches, outlets and fixtures because it can overheat. Consult with a qualified electrician to remove all aluminum branch wiring.

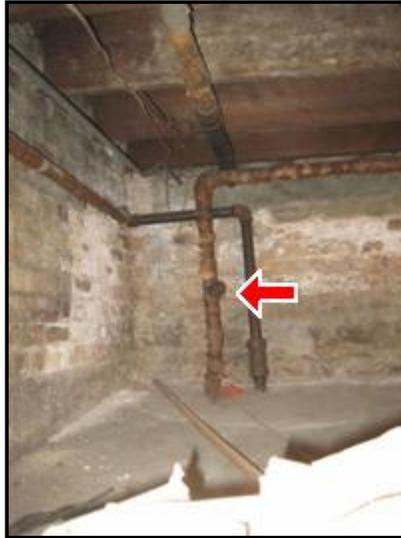
C. Picture 1

The water main and much of the supply piping is 'insulated' with newspaper. We recommend removing this insulation so the pipes can be inspected. Replace the insulation with foam.

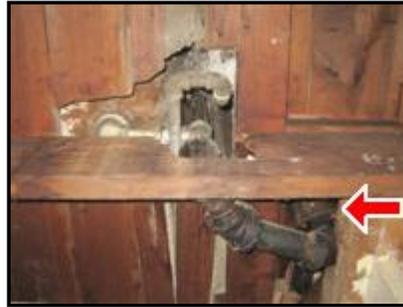
E. Picture 1

(2) Drum traps are present on the bathroom drains. These are common in older homes but can lead to slow drainage. Additionally, they need to be cleaned periodically which can be a messy under

taking. Recommend consulting with a qualified plumber to replace the drum traps with modern P-traps.

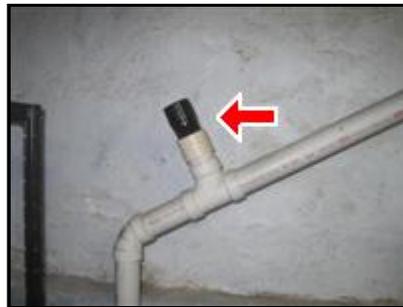
F. Picture 1

The kitchen drain does not appear to be properly vented in the main kitchen stack. A vent has been added on the line that releases into the basement. Why was this done? Consult with a qualified plumber to evaluate and repair as necessary.

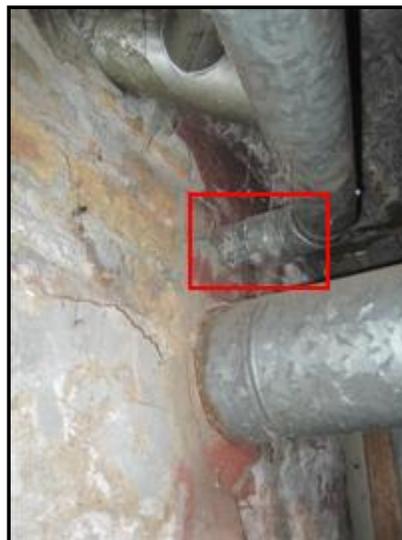
K. Picture 1

The water heater flue should increase at least 1/4 inch per foot. This flue turns downwards where it enters the chimney. This can lead to improper drafting. Consult with a qualified plumber to properly pitch this flue.

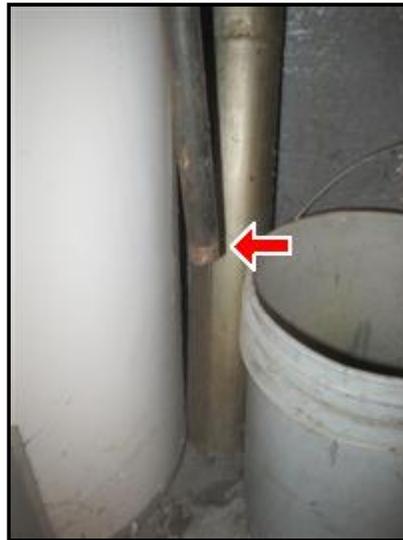
O. Picture 1

The extension pipe on the temperature pressure relief valve has threading on the bottom edge. This is not recommended because a cap could be screwed onto the bottom of this pipe. Covering this pipe could cause the water heater to explode in a high-pressure situation. Replace the extension pipe with a non-threaded pipe.

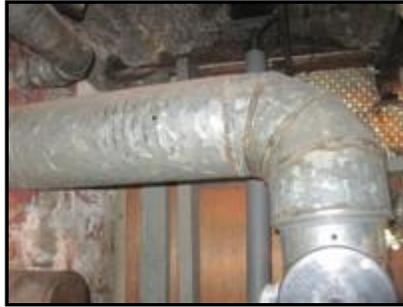
G. Picture 1

The boiler flue is corroded. This can be a sign that the flue is not drafting properly. This should be further evaluated by a licensed plumber or HVAC contractor at the tune up. It is possible that this corrosion occurred before the chimney liner was installed.

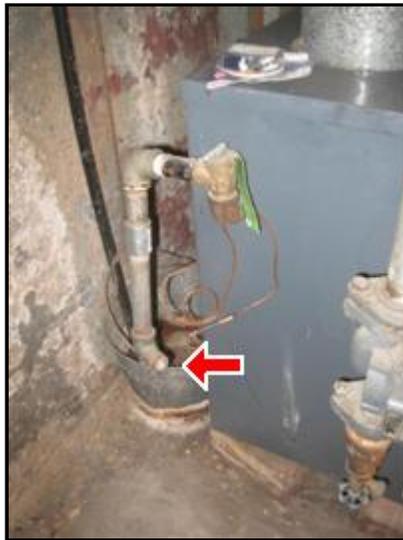
K. Picture 1

The pipe extension that should run from the temperature pressure relief valve to the floor is too short and it bends so that water could be released onto people. Please extend this pipe so that it is no more than 6 inches from the ground and it is a straight pipe. If there is a near-by floor drain or drip pan, then the pipe should be extended into one of these facilities.

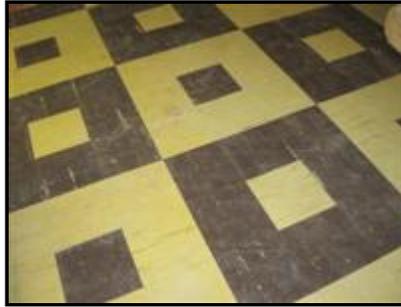
B. Picture 1

(1) The floor tiling in the basement may contain asbestos. Please consult with a qualified environmental testing company to determine if these tiles contain asbestos. Asbestos floor tiling was common in the 1940's and 50's. Most asbestos floor tiles are either of a 9x9 or 12x12 size. Typical protocol requires either covering the floor tiles (without nailing into them) or removing them. Follow all federal laws when removing or handling asbestos materials.

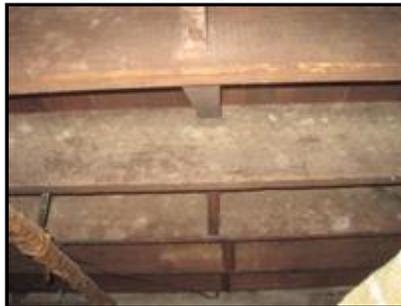
B. Picture 2

(2) A small amount of a possible mold-like substance was visible on some ceiling joists. This is likely from ongoing high humidity levels due to poor ventilation and foundation seepage. Consult with a qualified mold remediation contractor to determine the best way to manage this substance.

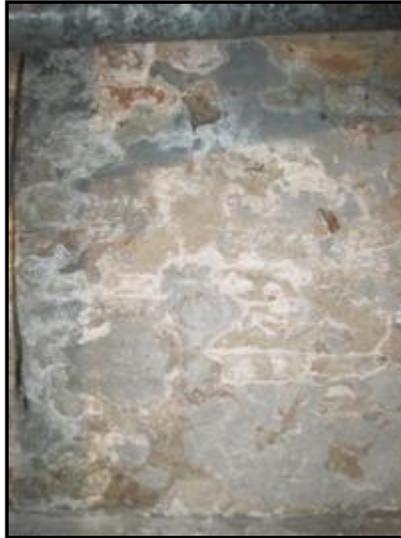
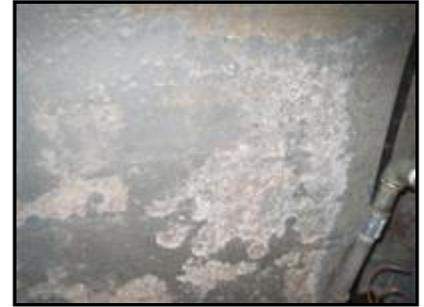
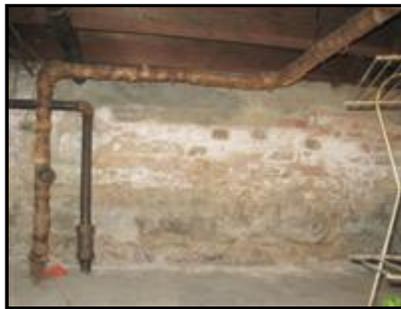
It is very common for there to be evidence of seepage in old foundation walls. Seepage generally occurs because of poor exterior grading and foundation deterioration. The presence of efflorescence on the walls (white mineral deposits) is an indication of ongoing seepage. We do not recommend finishing basement walls where seepage is occurring because the moisture can cause mold growth on wall board. Consult with a qualified basement water proofing contractor to determine the best ways to reduce seepage for this property. Photos show examples of heavy seepage on the south and west walls. We could not see the east wall because of the wall finishes.

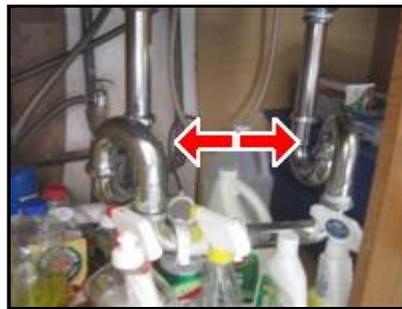
M. Picture 1

Both sink drains have S-traps instead of P-traps. S-traps can allow sewer gas into the home. Consult with a qualified plumber to replace the S-traps.

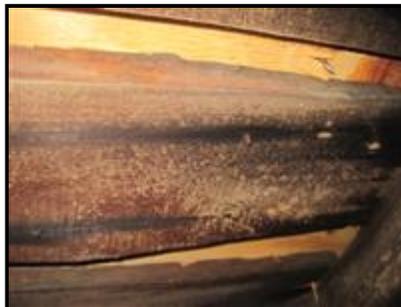
C. Picture 1

There is a significant amount of a mold-like substance present throughout the attic sheathing. This type of growth can occur because of ice damming in the winter and/or high humidity levels in the summer. See notes in the Insulation and Ventilation Sections for more information regarding ice damming and moisture levels in attics. Once all moisture related issues are resolved in the attic, consult with a qualified mold remediation contractor to address the existing substance throughout the attic space.

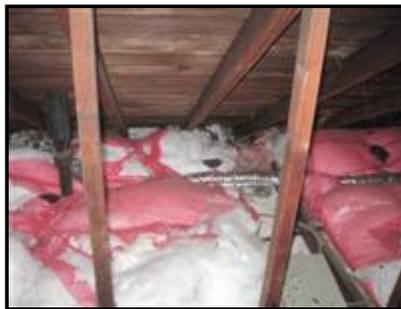
The ventilation in this home does not appear to be sufficient because the soffit vents are blocked. Consult with a qualified contractor to add baffles so that air can flow through the soffit vents. Also be sure to use the fan in the summer. (Picture 1)

F. Picture 1 Insulation in soffit vents
