Inspection Report

Punchlist Example Chicago IL

Property Inspected
Punchlist Example
Chicago IL

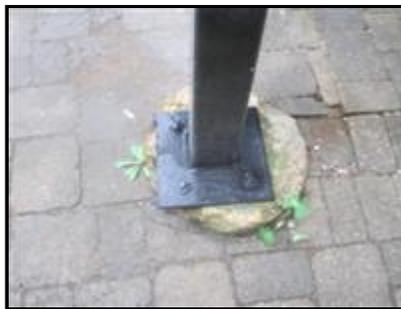
E. Picture 1

(1) The deck columns are not properly seated on the footings. Consult with a qualified decking contractor to determine the best way to support these columns. There are 2 columns that are overhanging the footings. Photo shows west column.
-

(1) The deck columns are not properly seated on the footings. Consult with a qualified decking contractor to determine the best way to support these columns. There are 2 columns that are overhanging the footings. Photo shows west column.

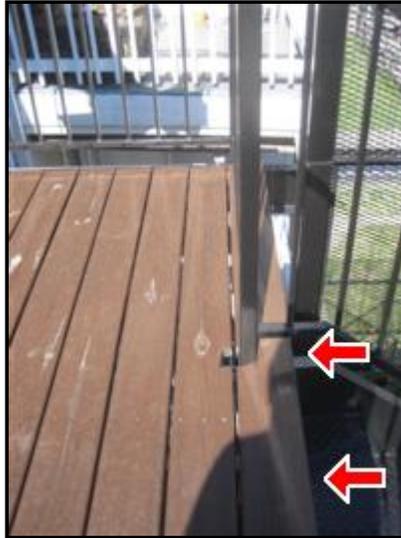
E. Picture 2

(2) Secure all loose/lifting deck boards on the back deck system. Numerous boards are lifting which creates a tripping hazard.

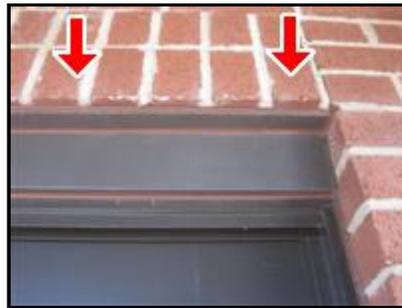
B. Picture 1

(3) Caulking has been added between the door and window lintels and the masonry above the lintels (several back and front deck doors). There should be an open gap between the lintels and the masonry because water needs to drain out of the walls above the lintels. Adding caulk in the gap can trap water in the walls and cause interior leaking. We highly recommend removing all caulking between lintels and masonry.

🏠 (3) Caulking has been added between the door and window lintels and the masonry above the lintels (several back and front deck doors). There should be an open gap between the lintels and the masonry because water needs to drain out of the walls above the lintels. Adding caulk in the gap can trap water in the walls and cause interior leaking. We highly recommend removing all caulking between lintels and masonry.

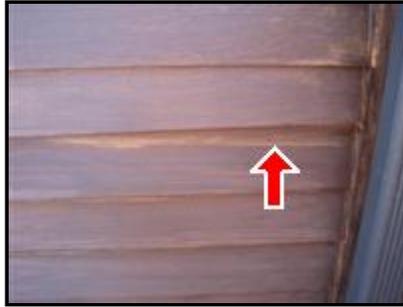
The siding on the upper front and back deck walls is not well installed or well stained. Some pieces are loose and/or falling. Consult with a qualified siding contractor to secure all loose siding. Add a new coat of paint/stain.

🏠 The siding on the upper front and back deck walls is not well installed or well stained. Some pieces are loose and/or falling. Consult with a qualified siding contractor to secure all loose siding. Add a new coat of paint/stain.

C. Picture 1 Loose siding piece - top level near west side

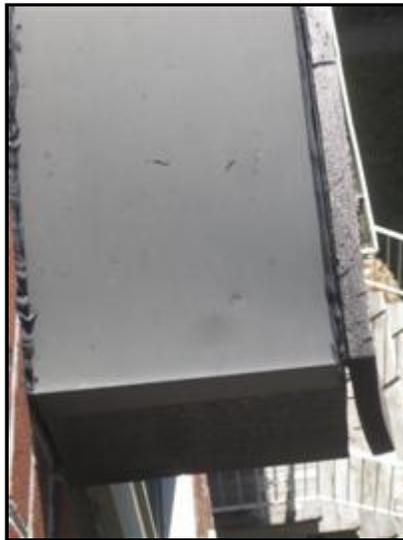
E. Picture 1

The wood trim above the top floor front windows is falling off. Replace this trim.

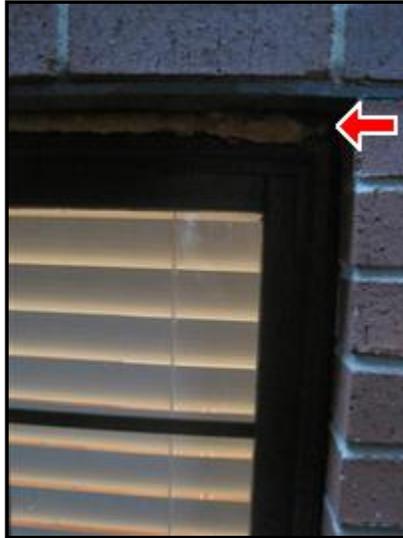
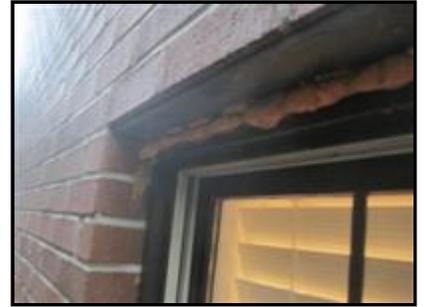
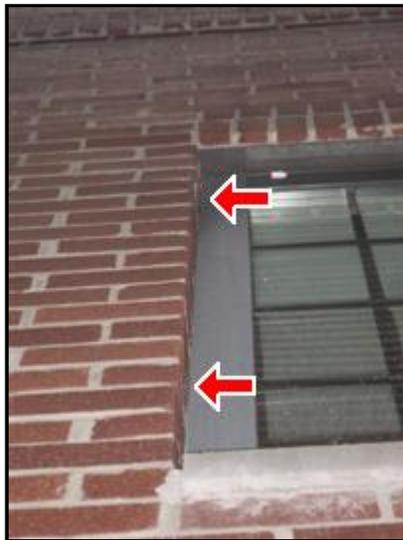
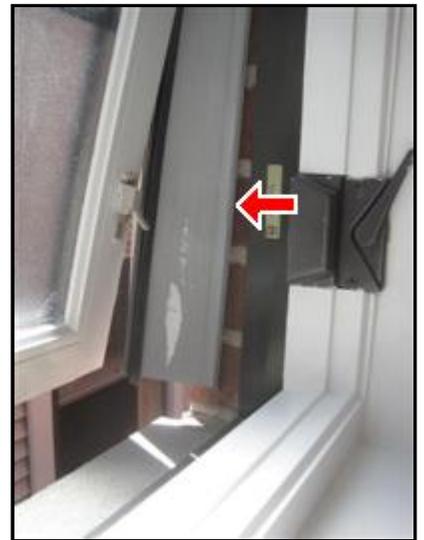
The trim around many of the window frames is not complete and insulation is visible. Other windows appear to have trim installed but there are large gaps and the trim is loose and/or falling. Consult with a qualified window contractor to repair the improperly installed trim and to finish the missing trim.

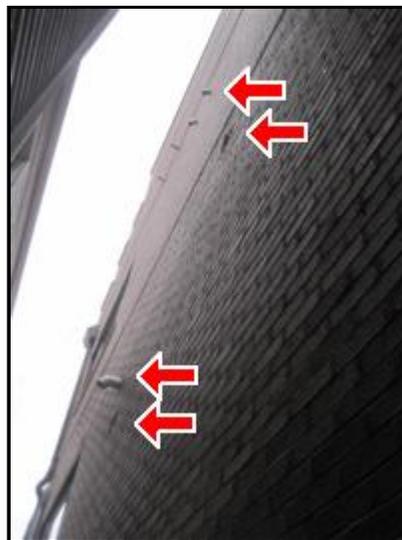
O. Picture 1

There are numerous incomplete vents on the east and west walls. Install all vent covers, elbows and screens. Then caulk all openings so the walls are water and critter proof.

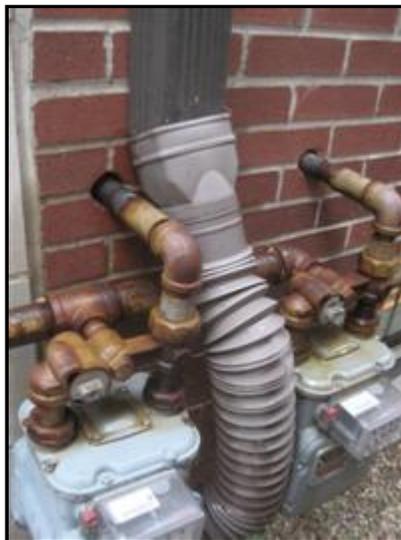
D. Picture 1

All plastic sections of the downspouts should be replaced with aluminum piping. Consult with a qualified contractor.

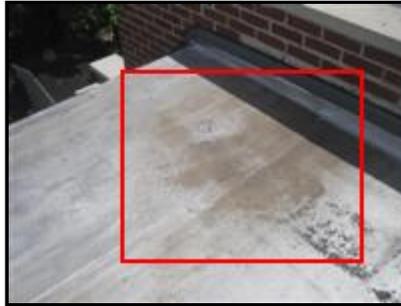
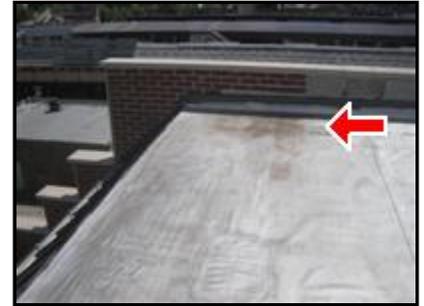
(1) Some minor ponding was noted on the roof in the NE corner - see photo. Re-pitch this area as necessary so water drains into the gutters.

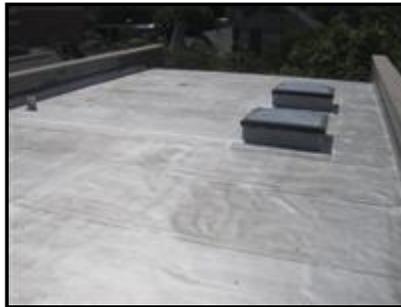
(2) The average life expectancy of a modified bitumen flat roof is about 18 to 20 years.

E. Picture 3 General view of roof

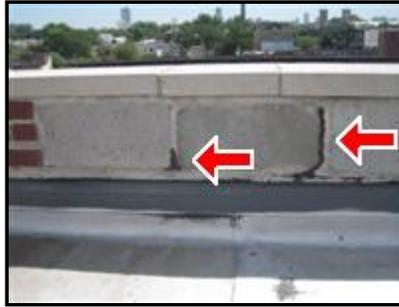
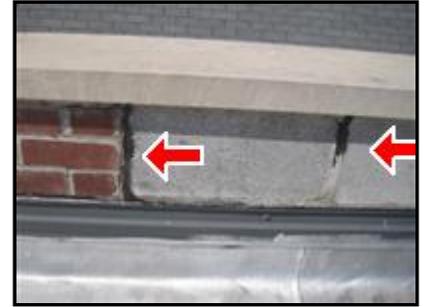
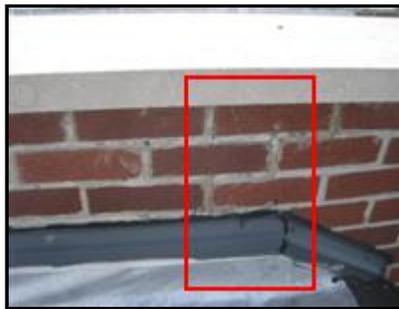
Additionally, there are cracks in these walls (both on the brick and the block) that need to be tuck pointed. Some of these cracks have been repaired with caulking. Caulking should never be used to repair masonry cracks. Remove the caulking and then tuck point the cracks by grinding out the old mortar and installing new mortar. Replace cracked bricks and blocks. Consult with a qualified mason.

L. Picture 2 Caulk on cracks

L. Picture 3 Caulk on cracks

L. Picture 4 Cracked bricks - east wall

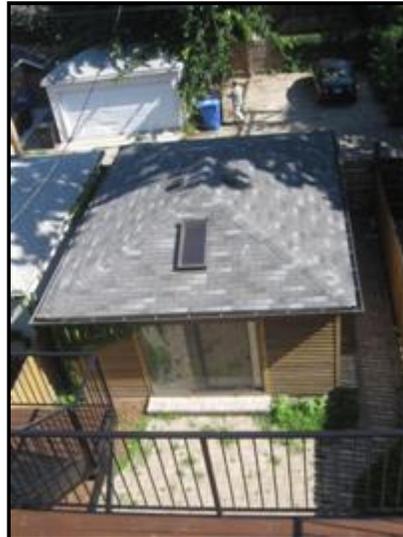
B. Picture 1

(1) Re-stain or paint the garage siding as necessary so the wood does not deteriorate.
-

(1) Re-stain or paint the garage siding as necessary so the wood does not deteriorate.

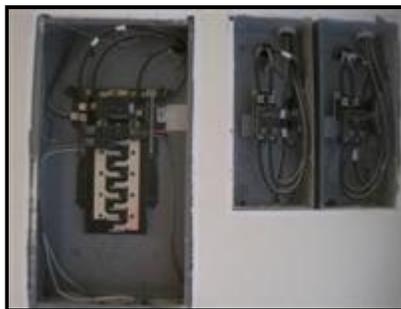
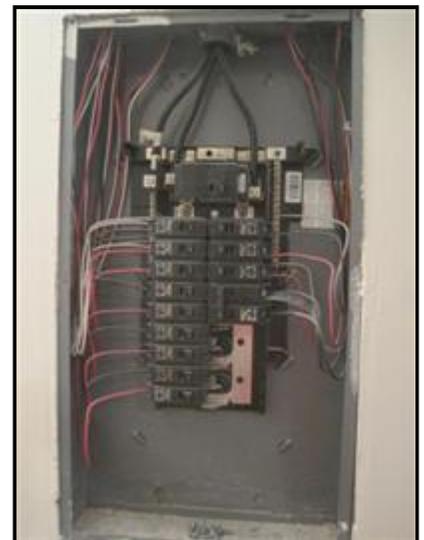
Photos show views of all 5 panels.

C. Picture 1 Public panel on left, 2 shut-off panels on right

C. Picture 2 Garden unit panel

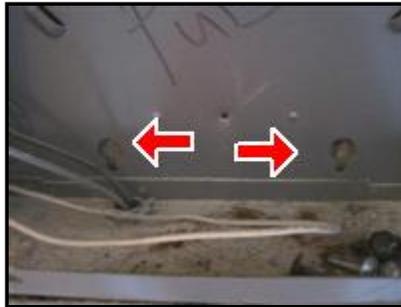
C. Picture 3

(2) Four of the electrical panels have been mounted in direct contact with the foundation - the 2 main shut off panels, the public panel and the garden unit panel (all located in the back basement hallway). Chicago does not allow this because moisture from the foundation can seep into the panel and cause corrosion. Panels should typically be mounted with an air gap between the panel and the foundation or a piece of plywood. Consult with a qualified electrician to remount these panels as required.
-

(2) Four of the electrical panels have been mounted in direct contact with the foundation - the 2 main shut off panels, the public

panel and the garden unit panel (all located in the back basement hallway). Chicago does not allow this because moisture from the foundation can seep into the panel and cause corrosion. Panels should typically be mounted with an air gap between the panel and the foundation or a piece of plywood. Consult with a qualified electrician to remount these panels as required.

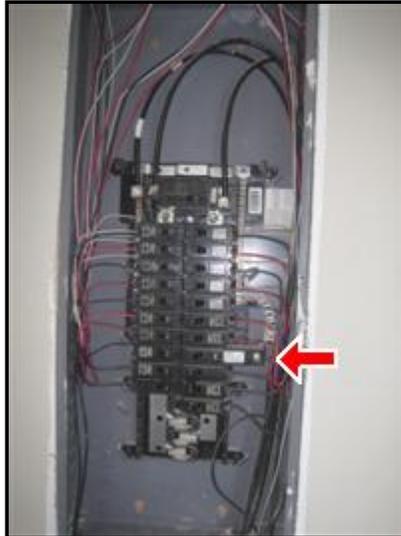
H. Picture 1

AFCI breakers are required on all bedroom circuits. There is only one AFCI breaker in the main panel. Consult with a qualified electrician to add AFCI breakers on all bedroom circuits, including the garden unit.

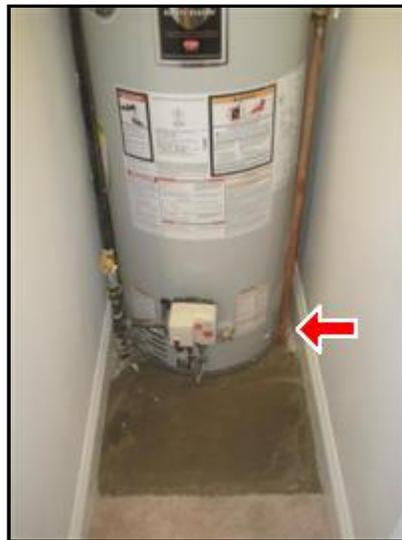
P. Picture 1

The temperature pressure relief valve on the garden unit water heater leaks when the water heater is running. This could be because of a faulty TPR valve or because there is too much pressure building up in the tank. Further evaluation and repair is needed. Once the water heater is repaired replaced damaged flooring, baseboards and drywall.

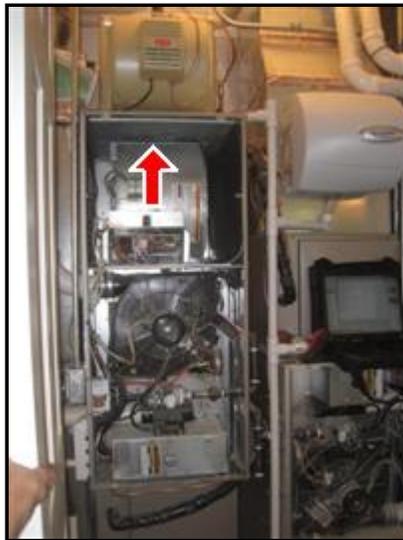
- The water line is not hooked up for the garden unit humidifier. Install water heater.
- The left humidifier is leaking heavily into the blower motor cabinet. We cannot see the underside of the humidifier to determine what is wrong. Consult with a qualified HVAC contractor to repair this humidifier and clean up the interior of the furnace.

J. Picture 1 Arrow shows area where water came from

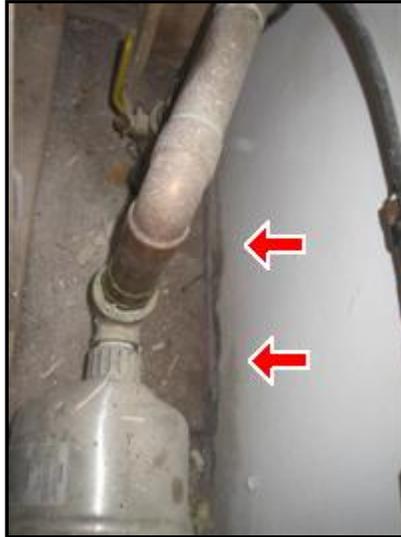
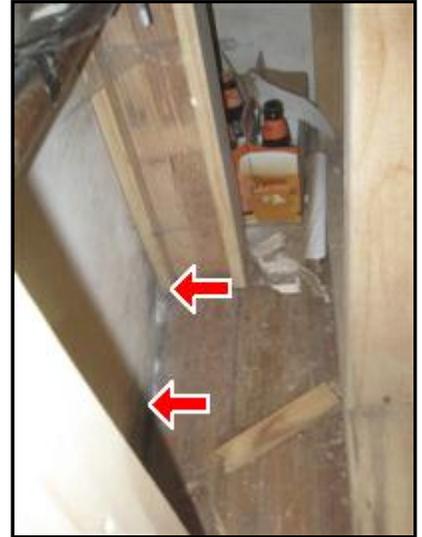
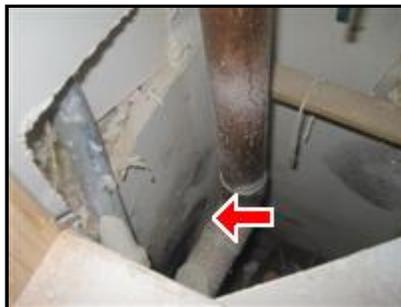
A mold-like substance was visible on the walls around the water meter (see photos) and a mold-like odor was present in the access panel for the whirlpool along the east foundation. Additionally, as noted below all of the drywall around the perimeter of the home below the foundation line was wet when tested with a moisture meter at the inspection. Mold can only be present when there is water and a food source for the mold. See the Moisture Section of this report for more information regarding the moisture. Given that some mold-like substance is visible we highly recommend either further mold testing to determine the extent of additional mold behind the walls or removal of the drywall/baseboards around the perimeter of the garden unit. Electrical facilities, wall studs, sills and insulation should also be checked for water damage and replaced once the seepage is stopped.

A mold-like substance was visible on the walls around the water meter (see photos) and a mold-like odor was present in the access panel for the whirlpool along the east foundation. Additionally, as noted below all of the drywall around the perimeter of the home below the foundation line was wet when tested with a moisture meter at the inspection. Mold can only be present when there is water and a

food source for the mold. See the Moisture Section of this report for more information regarding the moisture. Given that some mold-like substance is visible we highly recommend either further mold testing to determine the extent of additional mold behind the walls or removal of the drywall/baseboards around the perimeter of the garden unit. Electrical facilities, wall studs, sills and insulation should also be checked for water damage and replaced once the seepage is stopped.

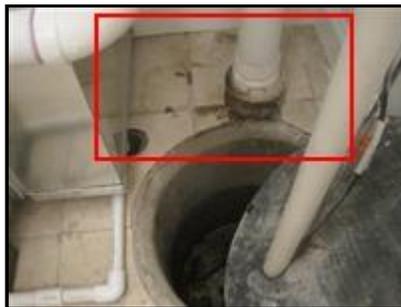
G. Picture 1

There is water damage on the tile around the sump pump and evidence of a mop being used. When/why did this pit back up?

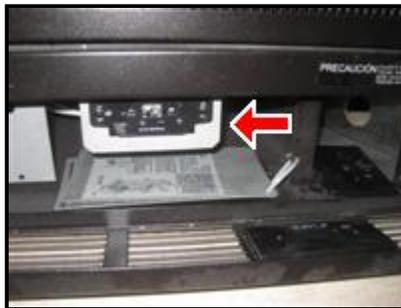
A. Picture 1

- (1) Please complete the following on the living room fireplace:
 - install a gas shut-off outside the firebox
 - install the face plate in the lower control panel - see photo

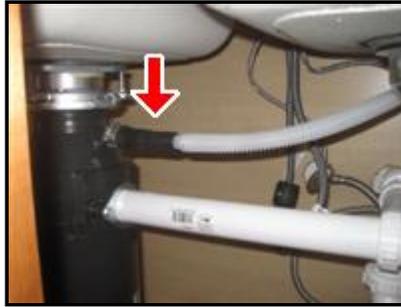
M. Picture 1

(1) The dishwasher drains is running into the disposal. This type of connection is not recommended because it creates a cross-connect between the two appliances. If the disposal is clogged and the dishwasher is running, it is possible to pull bacteria out of the disposal and into the dishwasher. Consult with a qualified plumber to connect the dishwasher drain properly (outside of the disposal). Garden unit.

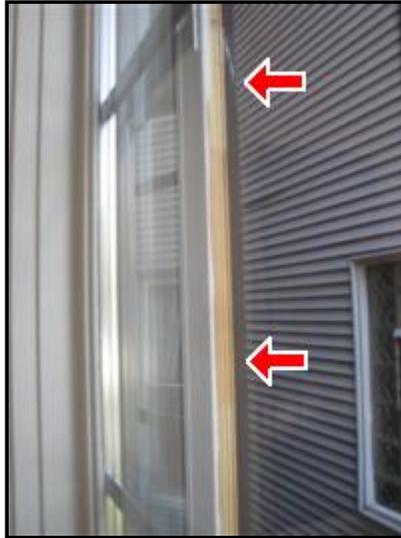
G. Picture 1

(2) Some parts of the wood window frames are not fully painted. The wood needs to be painted so it will not absorb water. Finish painting all operable windows.

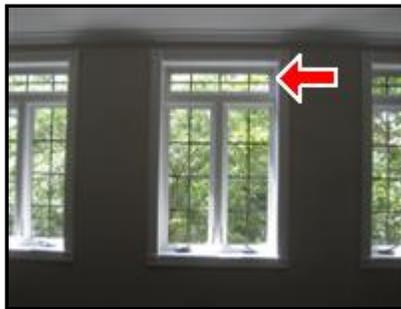
G. Picture 2

(3) The fixed pane window in the center of the front 2nd floor bedroom is cracked. Replace.

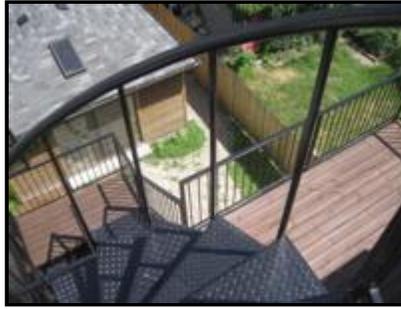
D. Picture 1

The spiral stair railings have gaps wider than 4 inches. This is considered a safety concern because children and small animals may slide through the railings. Consult with a qualified contractor to install railing spindles so that gaps are no more than 4 inches wide.
