Inspection Report

Split-block Example Chicago IL

All About Homes, LLC

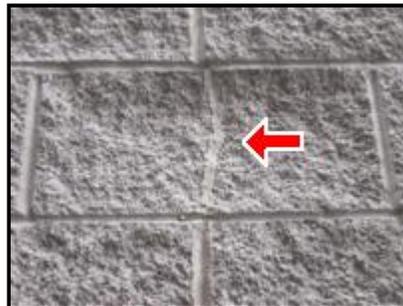
B. Picture 1

- Caulking has been used to repair cracks in blocks throughout the building (see photo). The use of caulk to repair cracking in block buildings is against the block manufacturer's recommendations and against the standards set by the National Masonry Institute. The use of caulking can trap water inside the block. We recommend that all caulking that has been used on this building be removed and that all cracks be properly tuck pointed (old mortar should be ground out and new mortar should be installed). Consult with a qualified mason to further evaluate this situation.

- Efflorescence and rust was visible on the concrete blocks throughout the east wall. Efflorescence is a mineral deposit left over after masonry products and water mix. Efflorescence on concrete blocks is generally a sign that water is getting into the block. If the blocks are properly sealed and the building is properly constructed, then only minimal amounts of water (ideally, no water) should enter the blocks and efflorescence should not be present. We cannot determine if the rust and efflorescence are present because of problems with the decking or because the masonry is taking on too much water.

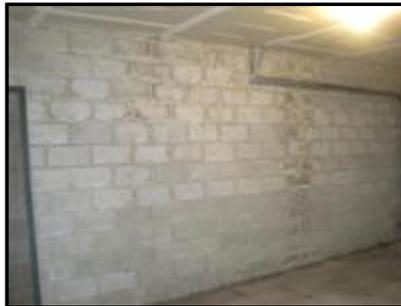
C. Picture 1

The interior concrete block wall in the garage has been leaking. See photo. There are water stains throughout the north wall. Has the garage been maintained/sealed in the same way as the main building? If so, this could be a sign that water has been getting into the concrete block walls. If this occurs behind drywall then mold-growth can become an issue. See notes in Exterior Section regarding concrete block.

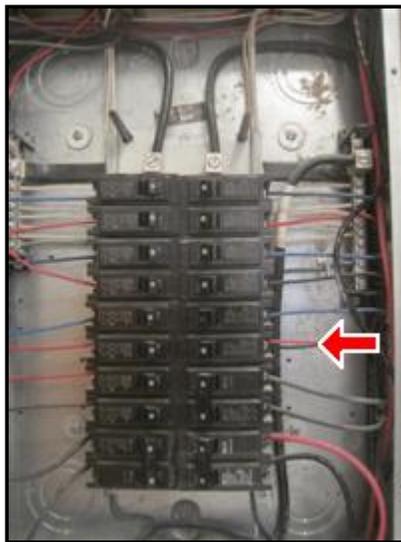
K. Picture 1

Double-tapping was noted in the electrical panel. One double-tapped breakers was present. Double-tapping means that two circuits are running into one breaker. This is a safety concern because the circuits can overheat and because wires in the panel can become loose. Consult with a qualified electrician to determine the best way to remove all double-taps.

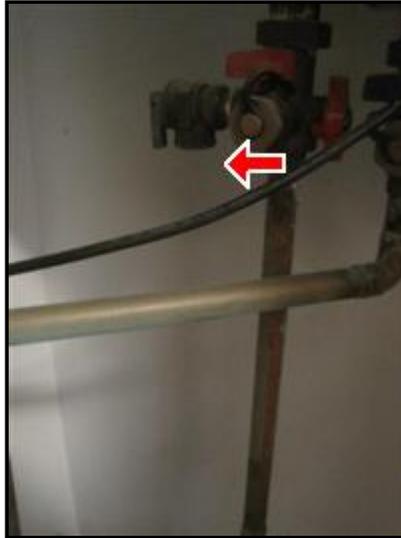
N. Picture 1

The temperature pressure relief valve should have a pipe extension that runs from the valve to within 6 inches of the floor. The extension is missing on this water heater. Consult with a qualified plumber to install the proper extension.

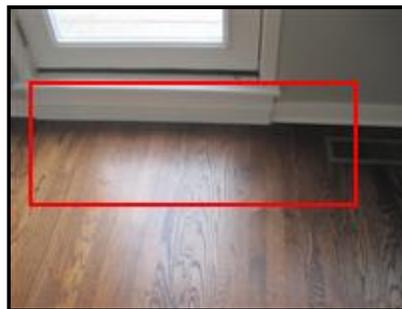
B. Picture 1

(2) It appears that the master bedroom roof deck door has been leaking. The floor in front of the door is water damaged. Moisture levels were elevated on this floor at the time of the inspection (tested with a moisture meter). Consult with a qualified general contractor or door contractor to repair this door so it does not leak. This leaking may be the cause of the water damage noted on the 1st floor bedroom ceiling. Once the leaking is stopped then replace/refinish the damaged floor boards.

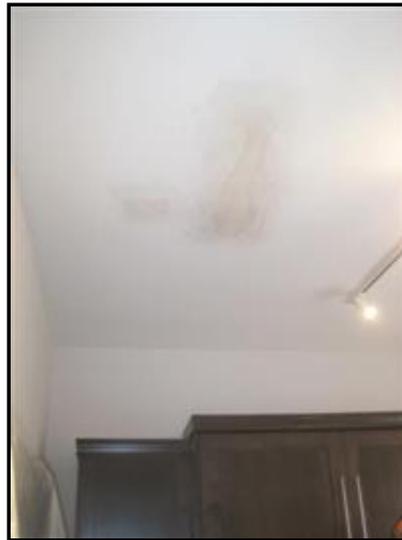
There is a large water spot on the ceiling of the 1st floor bedroom. Parts of this area were wet at the time of the inspection (tested with a moisture meter). This area is under the east master bedroom wall so there are a number of problems that could cause this leaking. Area to check include the connection between the roof (under the deck) and the east wall, the door flashings, the siding and the window flashings. It appears that caulking has recently been added on the siding but this does not appear to have stopped the problem. Additionally, caulking is not a long-term fix for this type of problem because it will fail over time. Consult with a qualified general contractor, roofer and/

C. Picture 1 Wet area on bedroom ceiling

or door installer to find the water source and make all necessary repairs.

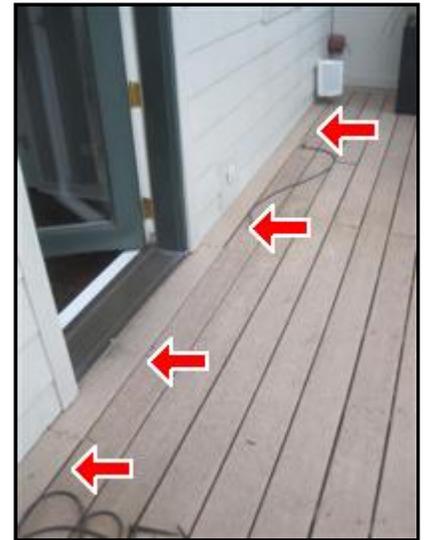
C. Picture 2 Roof connection to wall covered by decking

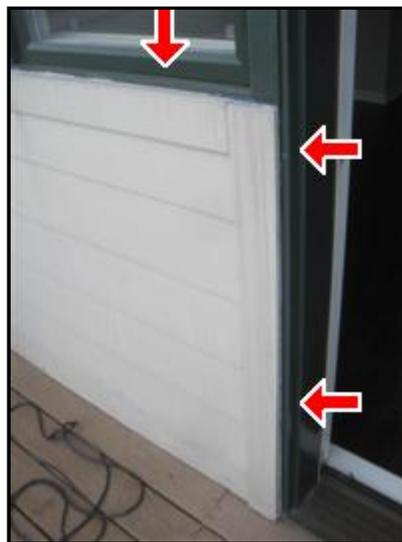
C. Picture 3 Recently caulked siding near door

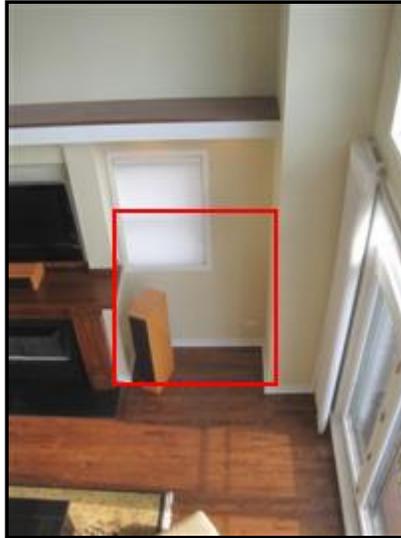
D. Picture 1

Water stains were noted on the walls/ceilings in several locations. We believe this interior leaking may be related to problems related to the concrete block. If the block is taking on too much water and/or not draining properly, then water can get stuck in the walls and come through the drywall.

- Wall on either side of the fireplace. Some cracking was noted so the walls were tested with a moisture meter and they were wet on both sides. Additionally some staining is noted near the base of the wall on the west side of the fireplace. Photo 1

- consult with qualified masons, architects and general contractors to determine why the water is getting into the walls
- make all necessary repairs to the masonry to stop the leaking
- remove all drywall and insulation on the impacted walls to determine the extent of the interior damage. Check for mold growth.
- check all electrical and low voltage facilities on the impacted walls for corrosion
- check the floor joists for water damage along the perimeter walls. If the joists have gotten wet then a structural engineer is needed for further evaluation
- remove and replace all impacted materials
- if mold is found in the walls then all proper remediation steps should be followed with a licensed mold remediation contractor

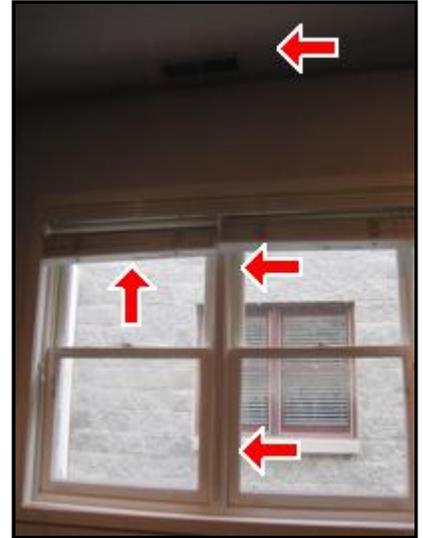
D. Picture 2

- Water stains are noted around the HVAC duct above the window in the 1st floor guest bedroom. Stains are also noted in the center of the window frame below the HVAC duct and on the base of the window blinds. Photo 2

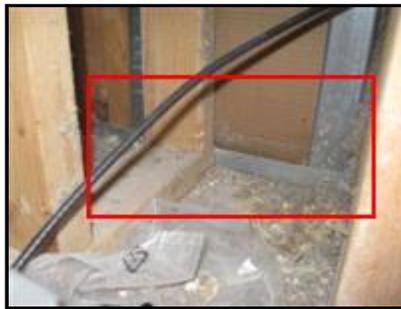
D. Picture 3

- Some buckling of the drywall/paint was noted under the master bedroom window. This could be from water damage or from poor drywall installation.
- Water marks were noted on the east wall that is visible through the whirlpool motor access panel. This may also be indicative of water entering through the block on the east wall. Photo 3

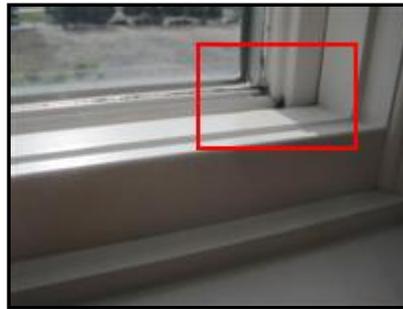
G. Picture 1

(2) There is evidence of damage to the window frames for condensation. There is a small amount of a mold-like substance on the north living room window on the west wall. Photo 1. There are also drip marks on the tops of many of the window sashes. These types of drip marks are often from condensation. Condensation can occur because of over humidification or because of high humidity levels in the walls due to the concrete block. It can also occur because blinds are left closed on cold days. We cannot determine the cause of the condensation damage in this unit.
