## Inspection Report

### 2-flat Example Chicago IL

2-flat Example

Chicago IL

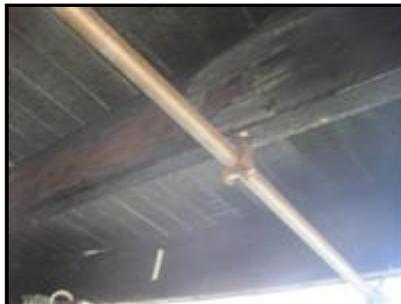
(2) Several joists on the exposed underside of the enclosed back porch are fire-damaged. When did a fire occur? These boards should be reinforced with sister boards. Consult with a qualified contractor.

C. Picture 1 Fire damaged joists in NE corner

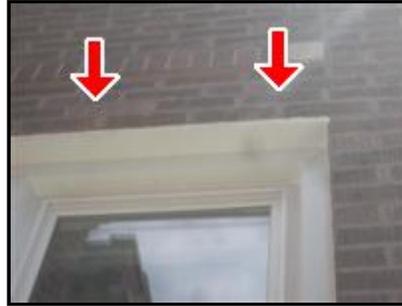
C. Picture 1

walls. The area above windows and doors is a natural drainage point for a masonry wall. Therefore it is important that water inside the walls be able to escape above the doors and windows. When the steel lintels are wrapped with aluminum and then caulked, as they have been on this home, water can become trapped on the lintels which leads to premature failure of the lintels. We recommend that all caulking be removed so that the lintels can "breathe". Consult with a qualified mason to make all repairs.

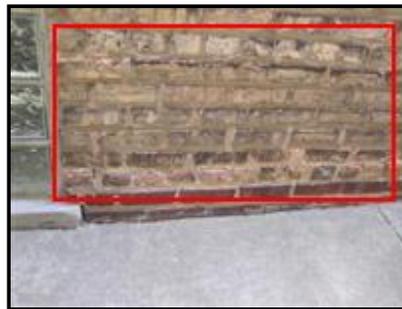
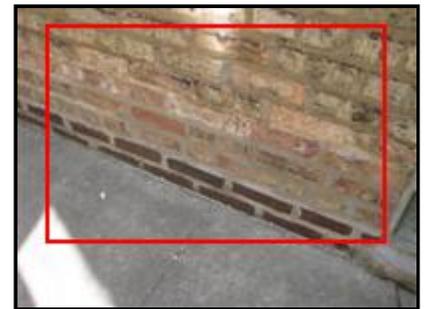
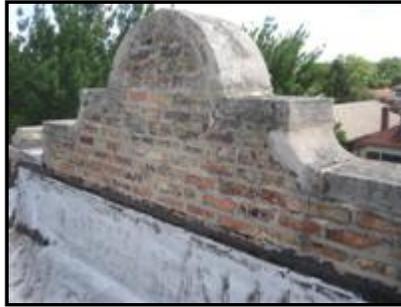
(2) Some areas on the brick walls need to be tuck pointed. Tuck pointing is recommended when any of the following conditions exist: 1) there is at least 1/4 inch mortar loss between bricks, 2) cracks are large enough to slide a business card through, and/or 3) the bricks are in any way deteriorated or damaged. Old mortar should be ground out prior to installing new mortar. If new mortar is installed without first grinding out the old mortar, the new mortar will not adhere properly. Be sure to obtain multiple estimates for work and hire only reputable and experienced masons.

The areas in need of tuck pointing the most include the base of the west wall (see photos 1/2) and the interior of the front parapet (photo 3).

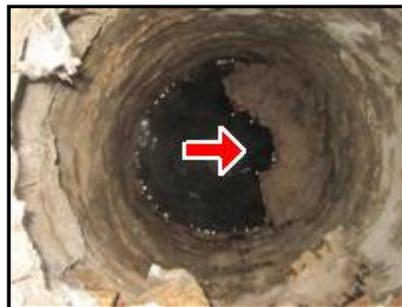
L. Picture 1

(3) The drain line in the catch basin no longer has a trap. This will allow debris in the basin to run through the drain line. We recommend adding a trap on this drain line. Consult with a qualified plumber to install a trap.

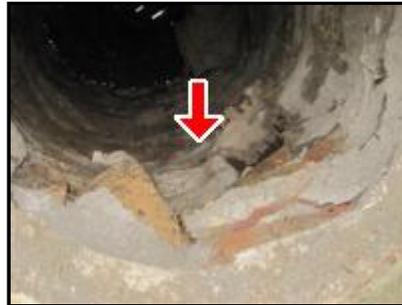
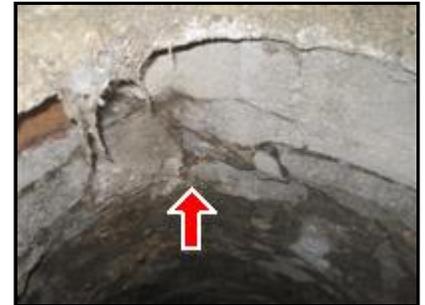
(4) The brick walls of the catch basin need to be repaired so that loose pieces of masonry do not fall into the basin and become lodged in the drain line. Consult with a qualified mason to make all necessary repairs.

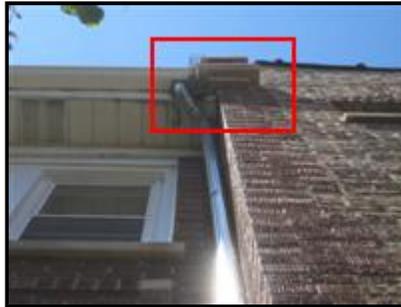
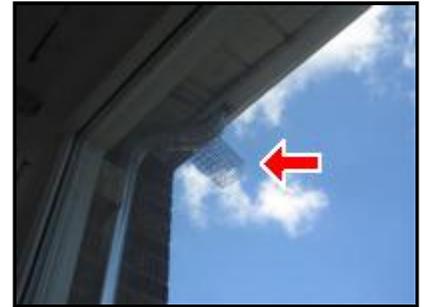
🏠 (1) There is unusual wire mesh in the gutter area on the east side of the home where the pitched section of roof meets the brick wall. It appears that this may have been added to keep critters out of the soffits. Please provide an explanation for the presence of this wiring. If this is present to keep critters out of the soffits then we recommend removing this mesh and working with a gutter contractor to repair the damaged soffit wrapping and fill all holes as necessary.

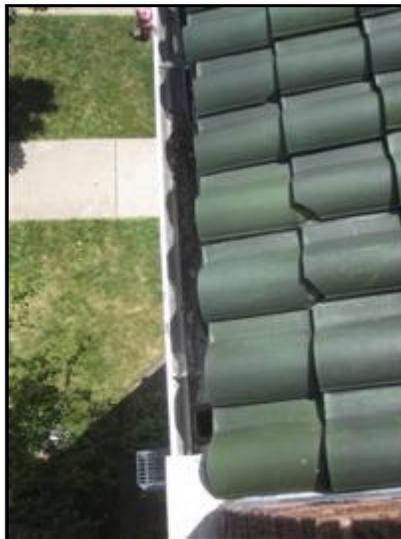
C. Picture 3

(2) We recommend removing the screens from the gutters around the tile roof. These have collapsed and are not trapping debris inside the gutters.

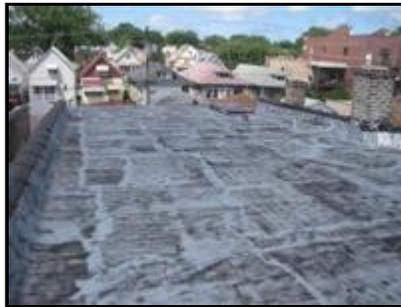
E. Picture 1

(1) The silver coating on the roof is worn. The silver coating is important because it reduces cracking in the membrane and reflects the sun. Consult with a qualified roofer to apply a new silver coating on this roof.

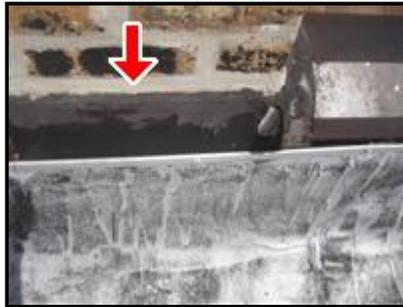
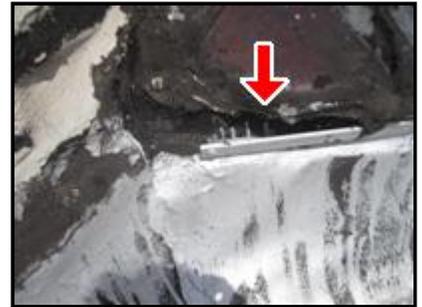
- 🏠 (1) There are 3 basic ways to connect a roof to the parapet walls.
- The preferred method is to roll the membrane over the top of the masonry and then install the wall caps. This keeps water from seeping through the caps and running into the walls. It also prevents the membrane from separating from the wall when it is attached vertically.
  - The next best method is to use metal termination bars to attach the roofing membrane onto the vertical parapet wall. The termination bars need to be properly fastened and caulking.
  - The least desirable way to connect the membrane is to use tar at the top edge of the roofing membrane on the vertical wall surface. As the tar fails/cracks the roofing membrane can pull away from the masonry and this can lead to leaking.

On this roof, termination bars have been used but they are not properly secured to the roofing membrane so they are not preventing the roof from separating from the parapet walls. Either add properly installed termination bars or roll the roofing membrane under the wall caps.

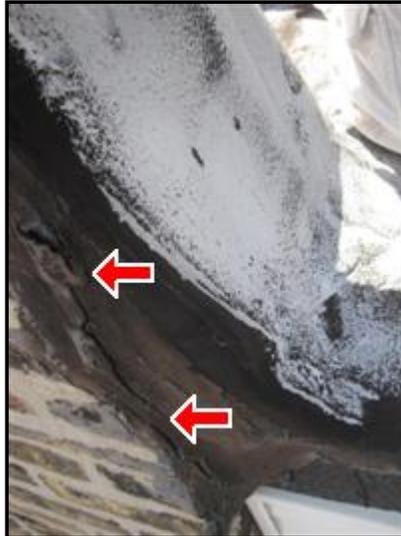
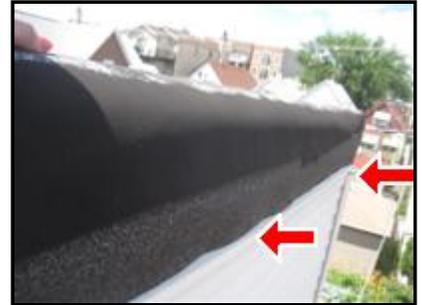
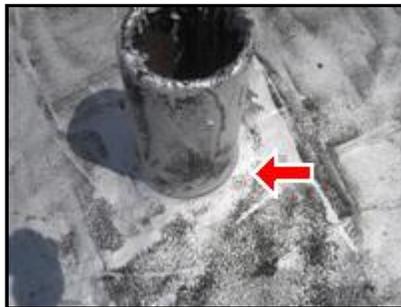
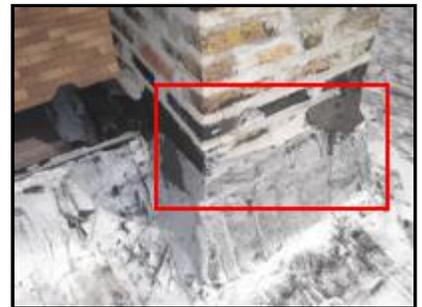
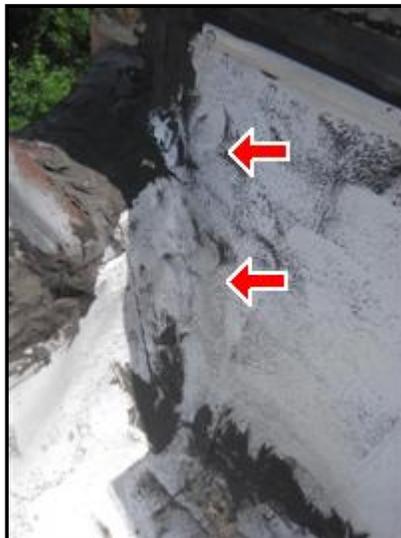
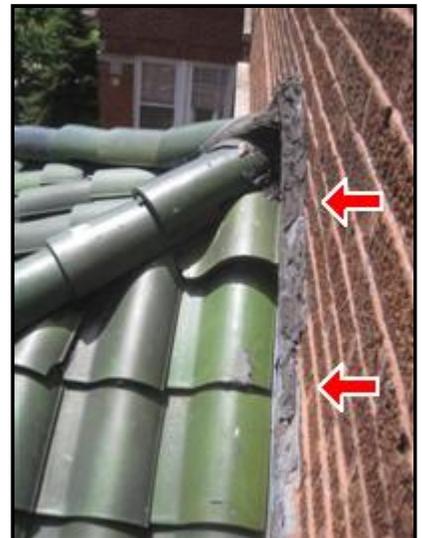
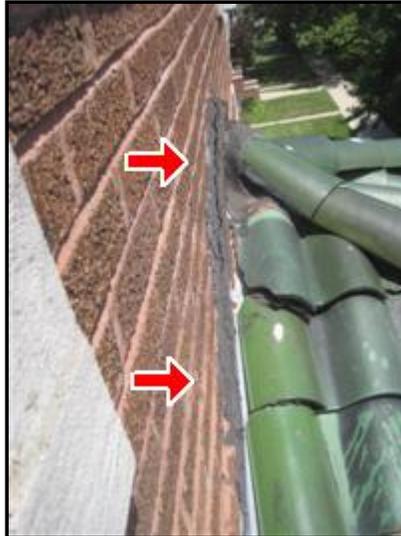
- 🏠 (2) Consult with a qualified roofer to make the following repairs to the roof flashings:
- The roofing material over the back porch is not well connected to the masonry or the sides of the porch. Photos 1/2
  - The flashings are cracking around the vents in the roof. Photo 3
  - Tar has been used around the chimneys. Tar is not a recommended flashing because it will crack and leaking can occur. Photo 4
  - The roofing membrane is cracking in the front corners of the roof. Photo 5
  - The tile roof is not well connected the south masonry wall. Tar has been used here and it is cracking. Photos 6/7

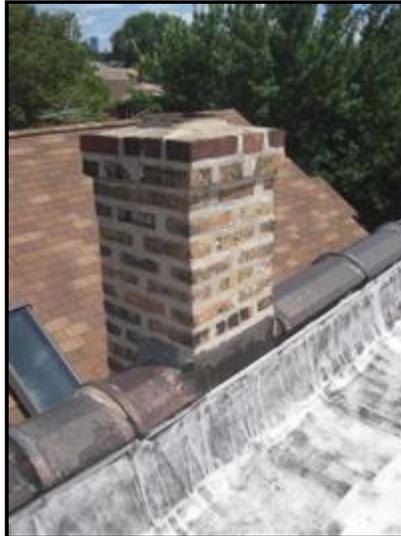
There are 3 chimneys on the east wall of the building. It appears that only the center chimney is in use. Therefore we recommend capping the other two so that critters do not become trapped inside.

A. Picture 1 North chimney - does not appear active

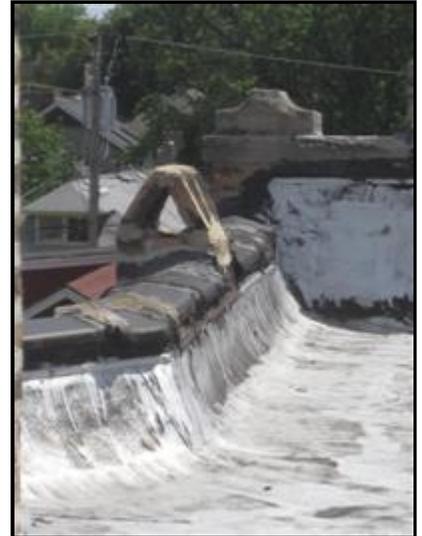
A. Picture 2 South chimney does not appear active

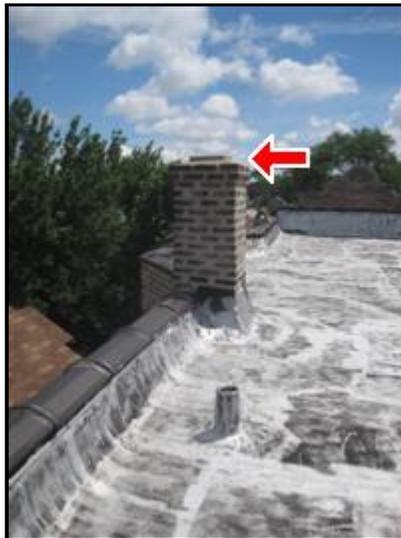
B. Picture 1

This chimney does not have a cap or screen. As a result debris and critters can enter the chimney. Chimney blockages can be very dangerous because flue gases can back up into a home. We highly recommend adding a proper chimney cap for the boiler and water heater chimney. Consult with a qualified chimney sweep.

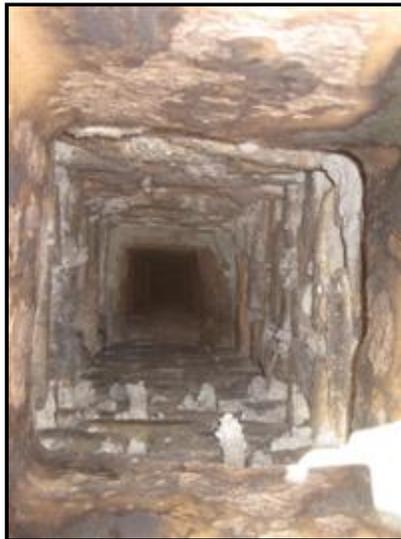
E. Picture 1

The boiler and water heater are relatively new. Newer gas appliances require smaller chimney flues than were originally built in homes of this age. To make old chimney's smaller, metal liners can be added inside old flues. The boiler/water heater chimney is not properly lined. Part of the flue is not lined at all and part has a heavily deteriorated clay liner. If the flue is not sized correctly or if there is deterioration, then the gas appliances may not draft properly and flue gases can end up in the home. Consult with a qualified chimney contractor to install a proper flue liner.

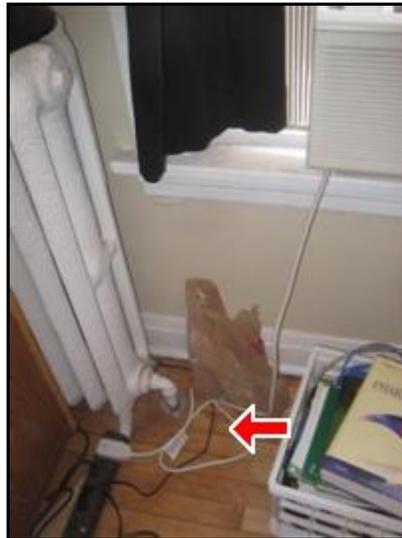
A. Picture 1

(2) All of the top floor units (3) are plugged in with extension cords. The window units need to be plugged directly into wall outlets that are grounded. Consult with an electrician to add the proper outlets within reach of the AC units.

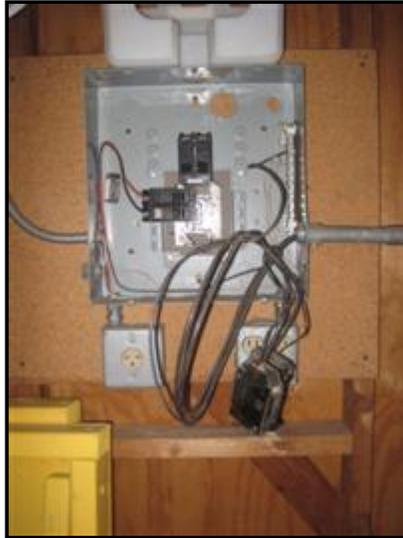
H. Picture 1

There is an electrical panel in the garage that has loose and exposed live wiring. See photo. The wiring that is here is not safe and does not appear necessary. Consult with a qualified electrician to remove this panel and properly wire the garage outlets and lighting. Be sure the outlets are GFI protected.

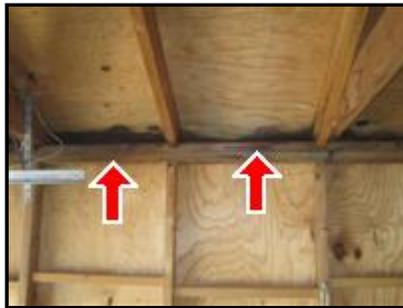
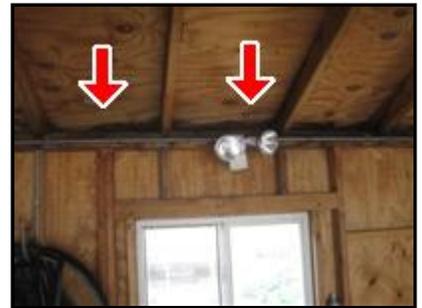
There is water damage and a mold-like substance on the roof decking at the soffits. The soffits, gutters and roof look satisfactory at this time. When did this damage occur? Did this damage occur before the new roof and gutters were installed? Monitor for ongoing leaking and repair as necessary.

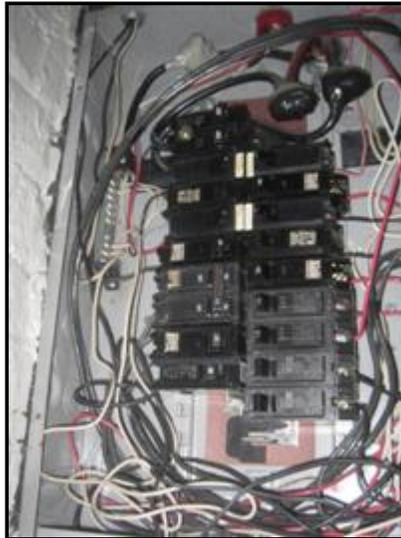
Please label all unlabeled circuits. Photos show panels.

C. Picture 1 Public + unit 1

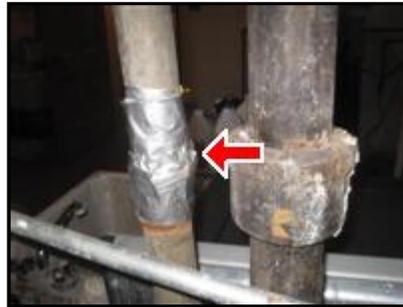
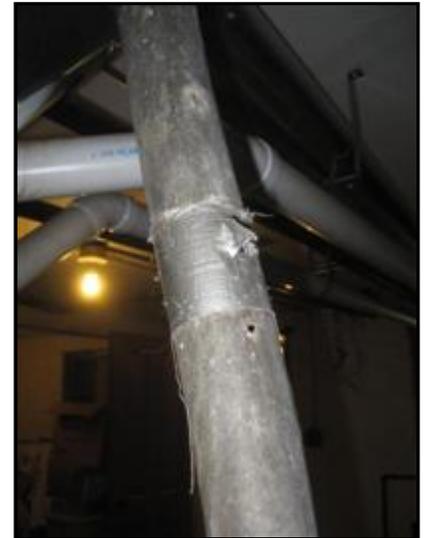
🏠 The pipe in the photos is likely the vent for the kitchen drain. It is held together with duct tape and has holes in it. Consult with a qualified plumber to replace this pipe.

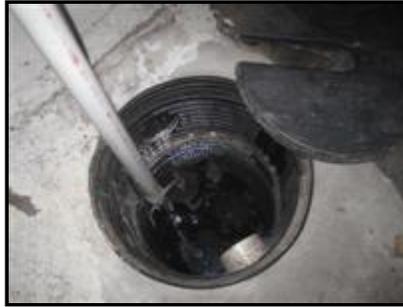
I. Picture 1

🏠 There is a pit in the basement with a pump. Why is this pit here? It does not appear that there are any drain tiles around the foundation. Was this installed to manage water if a flood occurs? The water in the pit was very stagnant and had a foul odor. We recommend adding a solid cover over the pit and a vent into the plumbing stack so that all odors are removed from the basement. Consult with a qualified plumber.

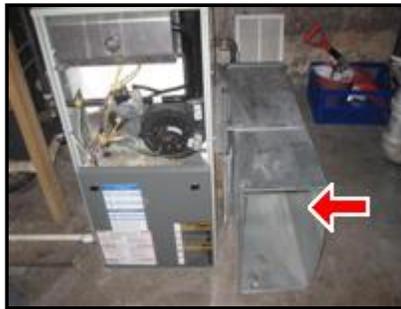
C. Picture 1

The cold air return for the basement furnace is not ducted. Cold air return ducts must be at least 3 feet from the furnace burners so that combustion gases do not get pulled into the main air supply. Recommend extending this duct away from the furnace. Consult with a qualified HVAC contractor.

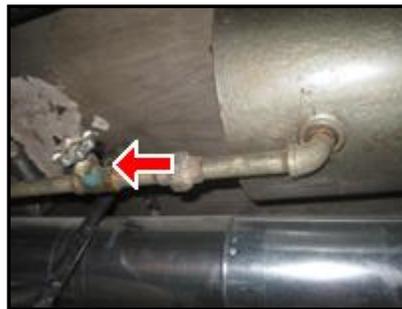
K. Picture 1

The water shut-off valve to the expansion tank is corroded. Consult with a plumber to replace this valve.

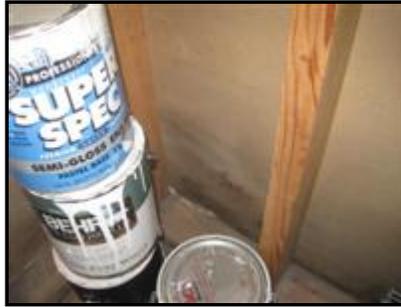
B. Picture 1

A mold-like substance was visible on some interior walls and on some parts of the foundation. Mold can only be present when there is water and a food source for the mold. See the Moisture Section of this report for more information regarding the moisture. Once the moisture source is identified and stopped, then all materials that were wet should be removed/remediated by a licensed mold remediation contractor.

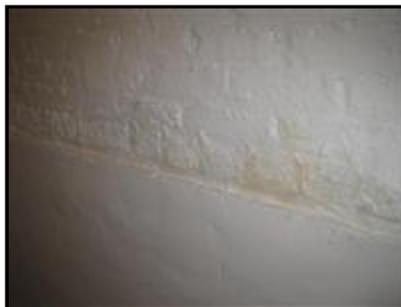
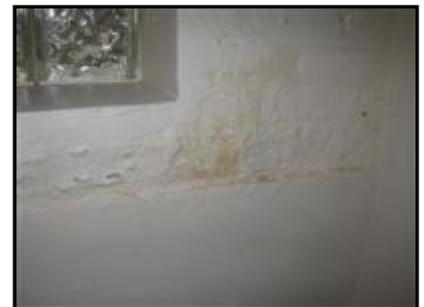
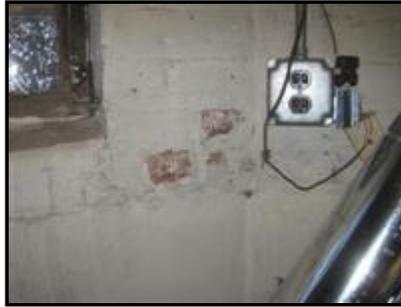
It is very common for there to be evidence of seepage in old foundation walls. Seepage generally occurs because of poor exterior grading and foundation deterioration. The presence of efflorescence on the walls (white mineral deposits) is an indication of ongoing seepage. We do not recommend finishing basement walls where seepage is occurring because the moisture can cause mold growth on wall board. Consult with a qualified basement water proofing contractor to determine the best ways to reduce seepage for this property. Compared with most properties this age, the seepage in this basement is fairly minimal. The seepage is worse on the west wall than the other walls.

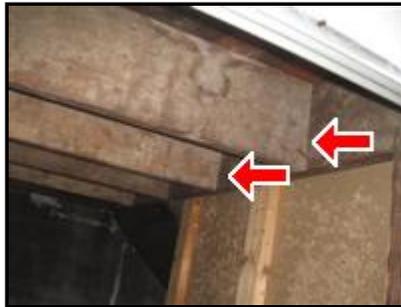
D. Picture 1

Recommend adding joist hangers to support the joists under the front stairs. See photo.

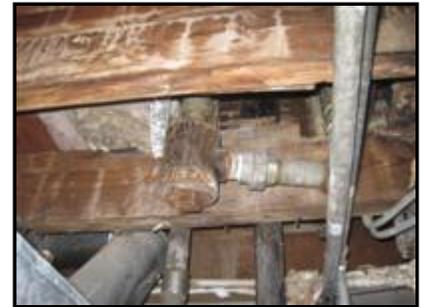
D. Picture 2

Reinforce the damaged and cut joists under the bathroom. See photo 2.

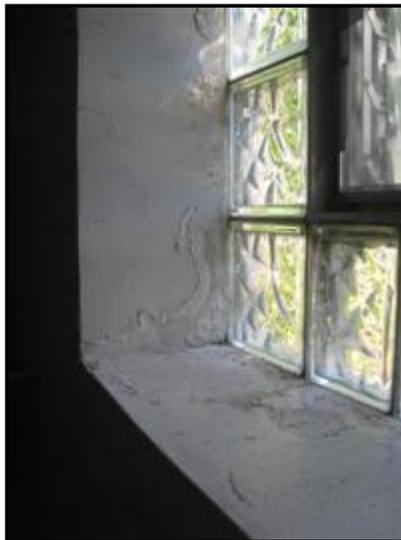
H. Picture 1

(2) There is water damage on the framing of the front basement window. The framing was dry during the inspection. We cannot determine if this is old damage that occurred before the blocks were installed or if this is actively leaking. Given that we have had a lot of recent rain, we expect this is old damage. Monitor for leaking and repair as necessary.

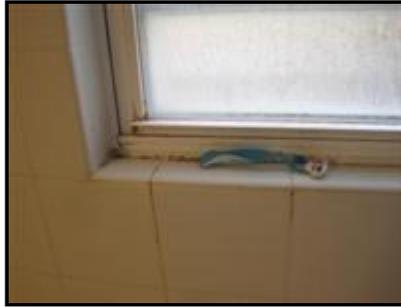
F. Picture 1

The vinyl replacement window in the 2nd floor bath is covered with a mold-like substance. We recommend cleaning with ammonia to try and kill the mold roots. Wait at least 24 hours and then treat with bleach to remove the stains. Be sure to protect this window from exposure to water as much as possible.

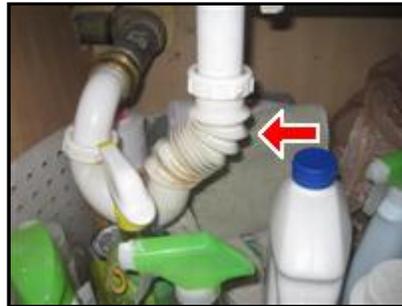
N. Picture 1

The kitchen drain is corrugated PVC. This type of drain piping can lead to slow drainage. We recommend replacing with solid piping. 1st floor

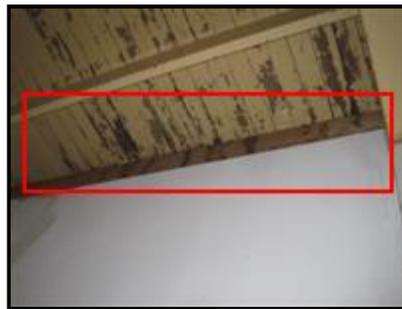
C. Picture 1

(2) It appears that water has been leaking in on the back porch where the gutters connect to the roof. This may be from ice damming in the winter. If ice damming occurs either insulate the attic space and/or add heating coils in the gutters.

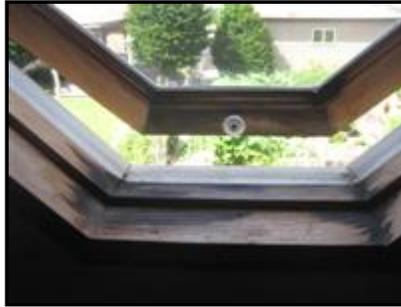
G. Picture 1

(4) The octagonal window on the back porch appears to be leaking. Repair/replace as necessary.
