Inspection Report

Townhome Example Chicago IL

All About Homes, LLC

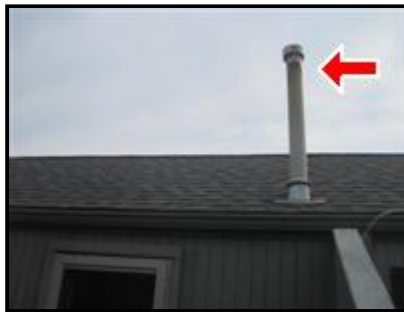
C. Picture 1

Chimney Chase: Metal Flue Pipe, Rusting
 The metal flue piping is rusting above the roof line. Seal with an anti-rusting agent.

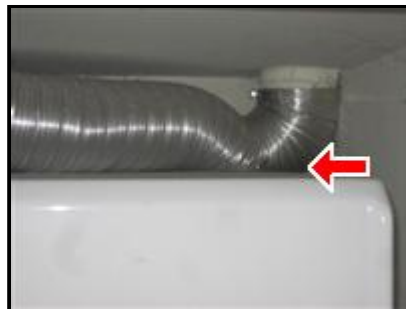
G. Picture 1

🏠 (1) The dryer vent is crushed on top of the machine. Install a new vent to replace the one that is crushed.

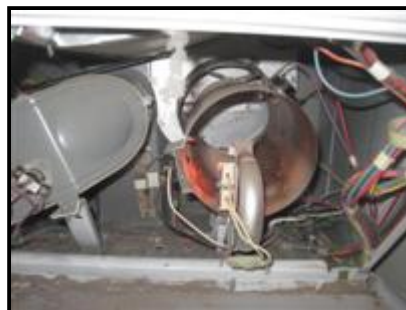
G. Picture 2

🏠 (2) There is a large amount of lint behind the machines and between the machines - see photo. Lint is very combustible and is a common cause of house fires. Please clean all lint from behind the machines.
