Inspection Report

Vintage Condo Example Chicago IL

All About Homes, LLC

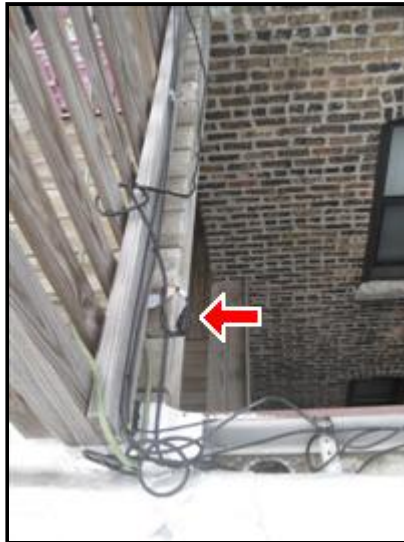
A. Picture 1

Gutters: Galvanized, Heating coils improperly installed

There are heating coils installed in the gutters to prevent ice damming in the winter. Extension cords have been used in this installation. Consult with a qualified electrician to add GFI protected outlets at the gutters so that no extension cords are needed.

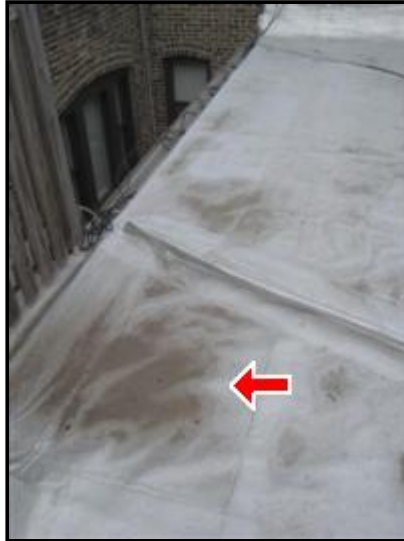
C. Picture 1

(1) Some minor ponding was noted on the roof. This area should be monitored for deterioration in the roofing material and may eventually need to be re-pitched so that water drains properly.

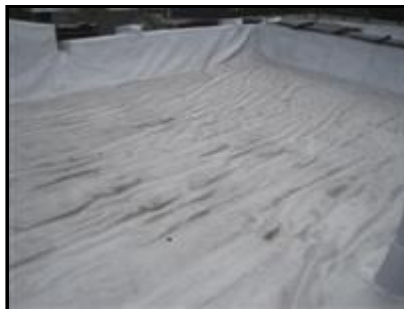
C. Picture 2

(2) The roofing membrane was not stretched properly at installation or it is sitting over several old layers. As a result, the membrane is loose and buckling. This can trap water on the membrane which will lead to premature failure. Consult with a qualified roofer to properly stretch the membrane and make all necessary repairs so the roof drains properly.

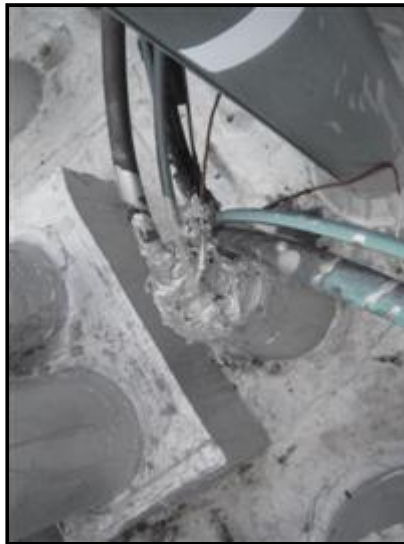
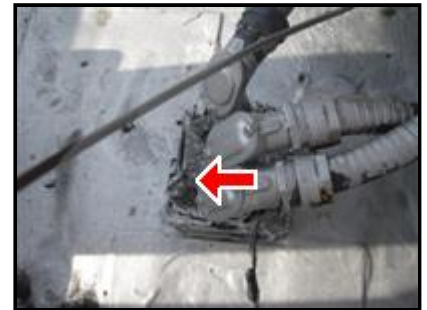
F. Picture 1

Flashing Condition: All flashings need repair

The flashings throughout the roof are in generally poor condition and need to be repaired. "Flashing" is a generic term that refers to the way in which the roof is connected to other things like parapet walls, chimneys and vents. In general, the flashings on this roof were not well installed and repairs are needed to prevent leaking. Consult with a qualified roofer to repair/replace the following flashings: parapet walls, chimneys, skylights, AC lines and all vents. Photos show examples.

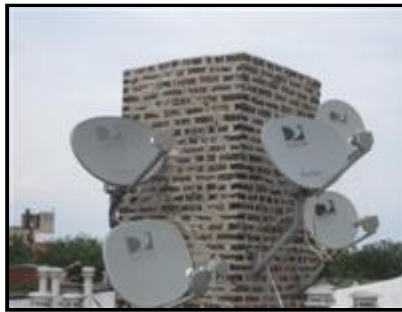
C. Picture 1

Chimney Chase: Brick, Metal Flue Pipe, Loose masonry
 The bricks at the top of the old boiler chimney are loose. When masonry is loose on a chimney, the top of the chimney will likely need to be rebuilt. This can be an expensive repair. Consult with a qualified chimney sweep or mason to rebuild this chimney as soon as possible.

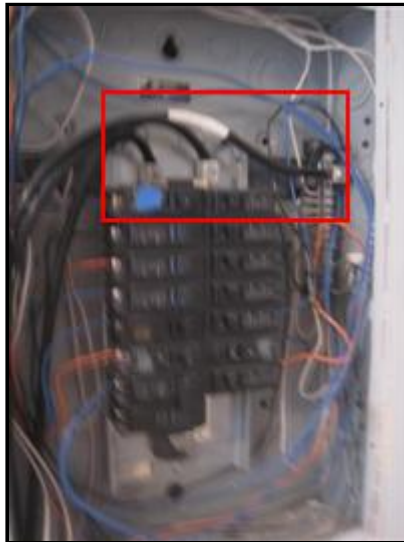
A. Picture 1

(1) The main wires have been pulled too tight in the panel. As a result the main lugs have been pulled forward. Have this evaluated and repaired if necessary by a licensed electrician.

(1) The main wires have been pulled too tight in the panel. As a result the main lugs have been pulled forward. Have this evaluated and repaired if necessary by a licensed electrician.

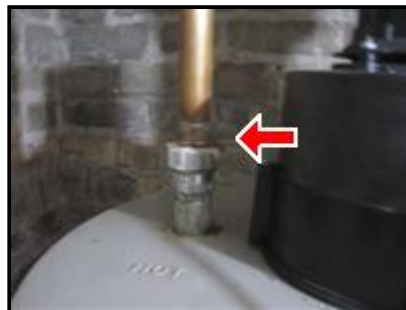
L. Picture 1

Water Heater Shut-offs: Corrosion on water outlet pipe

Corrosion was noted on the hot water line where it exits the top of the water heater. Consult with a qualified plumber to make necessary repairs in order to prevent leaking.

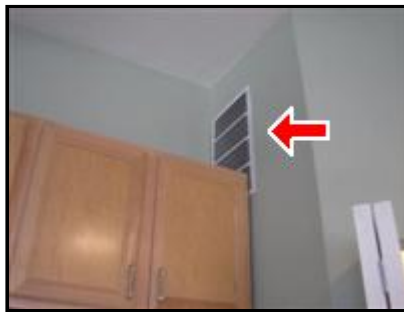
C. Picture 1

Ductwork: Metal, Most behind walls and not visible, Cold air return in kitchen

The cold air return is located in the kitchen. The kitchen has a gas stove. Cold air returns should not be located in kitchens with gas stoves because by-products from the burning gas can be pulled into the main air supply. Consult with a qualified HVAC contractor to move these cold air returns out of the kitchen.

The cold air return is located in the kitchen. The kitchen has a gas stove. Cold air returns should not be located in kitchens with gas stoves because by-products from the burning gas can be pulled into the main air supply. Consult with a qualified HVAC contractor to move these cold air returns out of the kitchen.

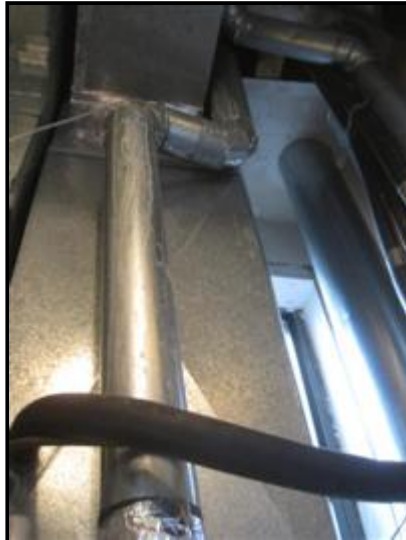
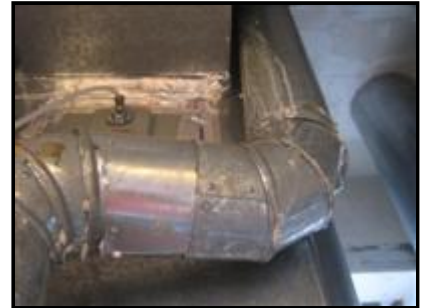
E. Picture 1

Furnace Flue: Metal, Corroded

The furnace flue should be evaluated for proper drafting by a licensed plumber or HVAC contractor. The flue is heavily corroded on its exterior which is typically a sign of drafting issues.

The furnace flue should be evaluated for proper drafting by a licensed plumber or HVAC contractor. The flue is heavily corroded on its exterior which is typically a sign of drafting issues.

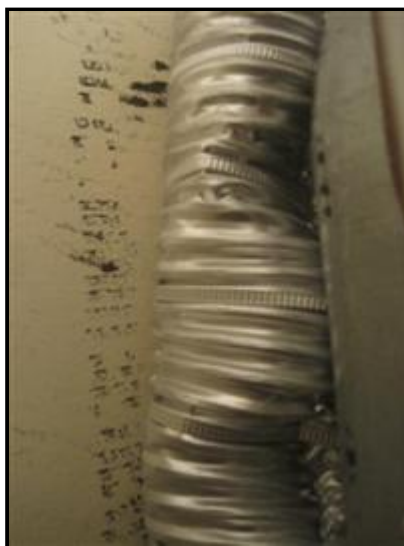
G. Picture 1

Dryer Vent: Replace or clean annually, Semi-rigid metal, Crushed, Clean lint from behind machines

(1) The dryer vent is crushed behind the machine. Please move the machines forward so the vent is not crushed. Install a new vent to replace the one that is crushed.

(1) The dryer vent is crushed behind the machine. Please move the machines forward so the vent is not crushed. Install a new vent to replace the one that is crushed.

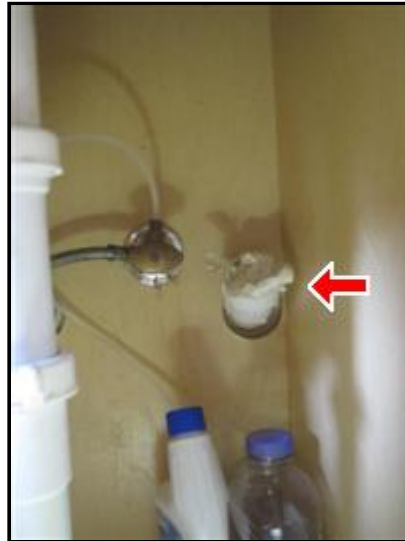
M. Picture 1

Sink Drain: P-trap, PVC

Cap the unused drain pipe under the sink.

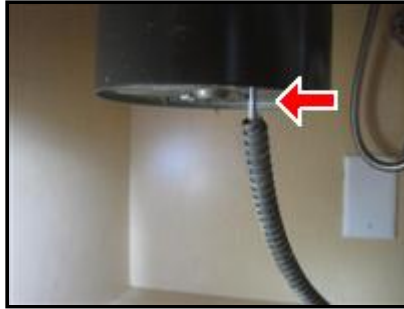
N. Picture 1

(1) The electrical wiring for the disposal is exposed. Repair conduit so wiring is protected.

(1) The electrical wiring for the disposal is exposed. Repair conduit so wiring is protected.

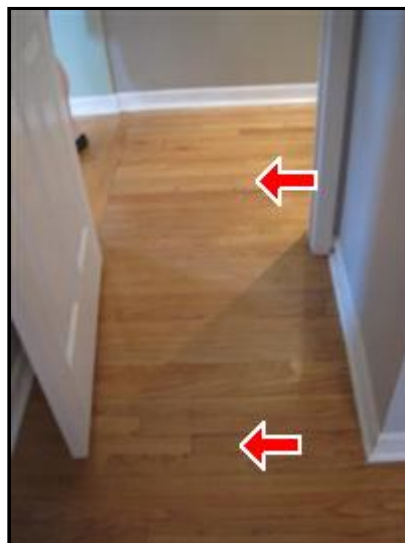
E. Picture 1

The floors in this home have typical vintage issues. Some areas are squeaky, some areas are unlevel and some areas are bouncy. This is all common in older floors and is typically not problematic. However, we cannot determine if any of this is caused by damaged, cut or deteriorated structural elements because the joists are not visible for inspection.

There are several areas where the floor boards are cracking and pushing in more than normal. The only way to fix this is to remove the boards and repair the joists below. Consult with a qualified flooring contractor.
